Machinery Messages

TDM 2 helps diagnose a crack on a charge gas compressor

by **Fabio H. G. Martins**
Maintenance Engineer
Petroquímica União S.A.
and
Rolando G. Dias
Manager/MDS Engineer
Bentley do Brasil Ltda.

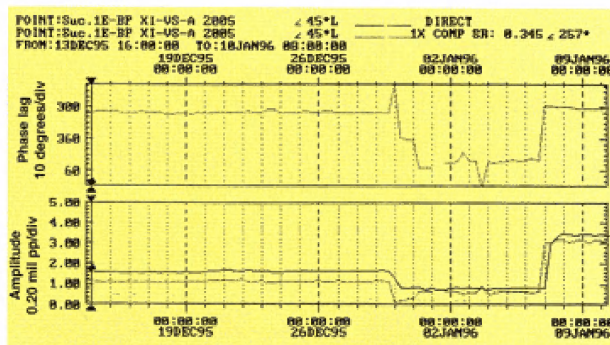
After the last overhaul in 1994, compressor vibration levels had been quite steady and acceptable. However, in late December 1995 and early January 1996, the plant experienced two shutdowns due to operational problems. The compressor was first stopped and then had its speed reduced. After these events, a sudden change was observed in overall vibration levels (Figure 2) in bearing #4.

The problem was diagnosed as a coupling B lockup because the vibration changes were sudden. There was evi-

dence of poor coupling lubrication and excess water, probably due to leakage in the turbine seals. It was recommended that a close watch be maintained. If vibration levels suddenly increased, the machine would be shut down and started up again. The procedure was to attempt a "release" of the coupling, through the axial displacement of shafts during the shutdown and startup.

Figure 2
Bearing #4 vibration trend plot (1X) between
13 December 1995 and 10 January 1996.

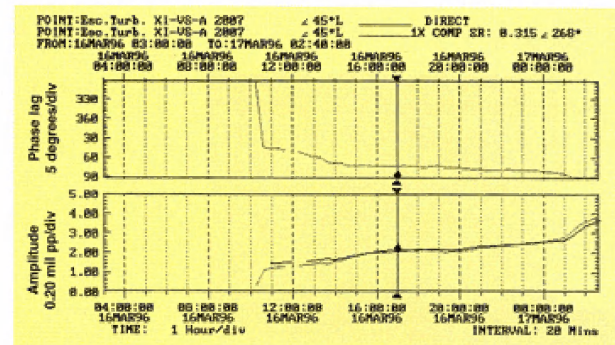
Figure 3
Bearing #2 vibration trend plot (1X).
16 to 17 March 1996.

- Predominant 1X vibration, continuously increasing.
- Continuous 1X vibration phase shift (Figures 3 and 4).
- 2X vibration at bearings #2 and #3, suggesting shaft stiffness asymmetry associated with a constant radial load.
- Banana-shaped orbit at bearing #4 (Figure 5), indicating excessive load, possibly due to gross misalignment or coupling lockup, due to poor lubrication.

Editor's Note: Two of the main shaft crack symptoms are 1X vibration change and phase shift. Note that after 20:00, 16 Mar 96, (Figures 3 and 4) the phase remained quite constant. One cause of the continuous phase shift during a shaft crack is the change in the radial direction of the lower shaft stiffness, as the crack propagates. It was already getting close to 50% of the coupling section, so the direction of lower shaft stiffness remained about the same. It is reasonable to conclude that, when the phase stopped shifting, the crack process did not stop. In this case, the crack reached 60% of the coupling section.

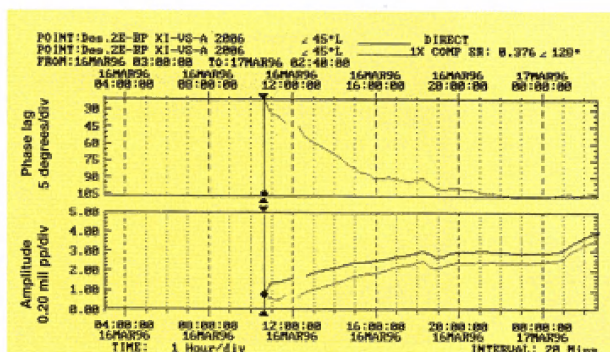
Figure 4
Bearing #3 vibration trend plot (1X).
16 to 17 March 1996.

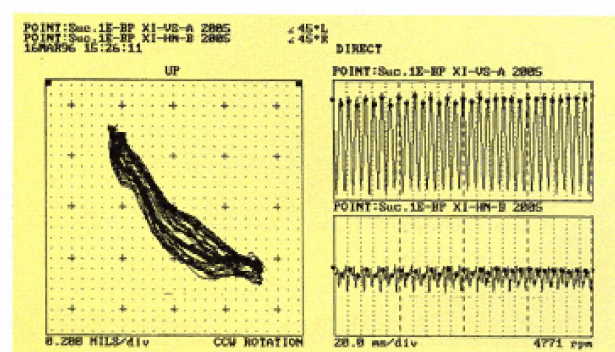
Figure 5
Bearing #4 orbit/timebase plot.
16 March 1996.

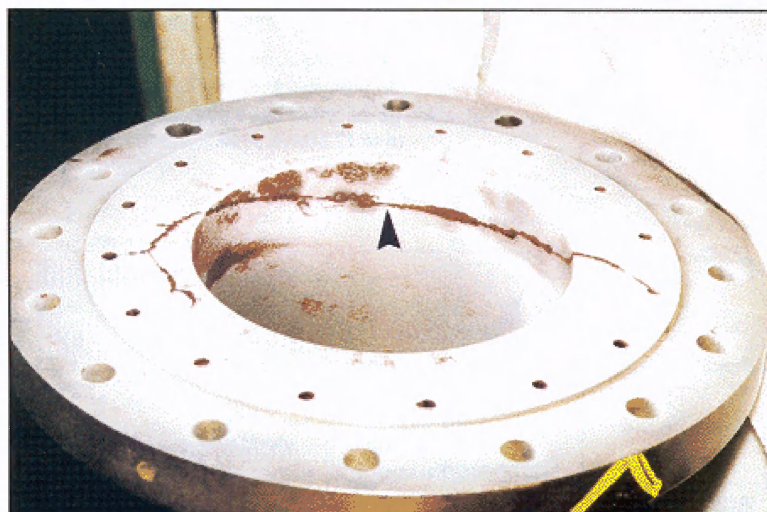
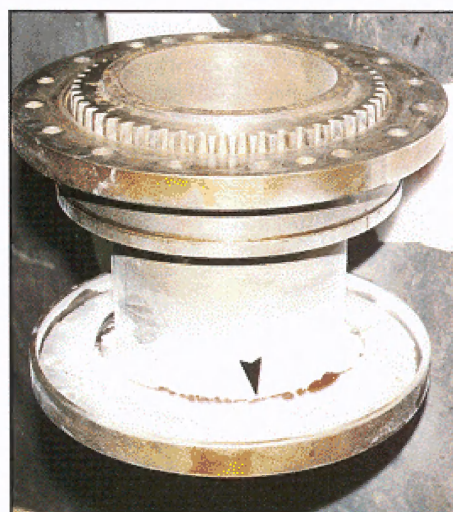
The inspection did find a crack, but in a different component, coupling A. There was a crack through nearly 60% of the coupling section (Figure 6 and 7). A fracture analysis carried out on coupling A showed that the crack was due to fatigue, starting at three different spots.

Coupling B lockup was also confirmed, due to a large amount of oil sludge inside. The same condition was found in couplings A and C.

- Lubrication oil was contaminated with water from a turbine seal leakage, producing oil sludge.
- There was sludge build-up around the coupling teeth, due to centrifugal forces.
- The coupling had locked up and began to act as a rigid body, unable to compensate for the residual misalignment.

- The coupling failed, due to fatigue caused by cyclic forces.

Figures 6 and 7
Internal and external view of cracked coupling. Arrow indicates location of the crack.
